Analyses of Post Dredged Surveys of Elechi Creek for Channel Condition Monitoring

Siltation is a major recurring phenomenon at the entrance into the channel of Elechi Creek, which is one of the busiest transportation routes to where some oil and gas production facilities and other key marine infrastructure are located in Port Harcourt City, Rivers State, Nigeria. Access into the channel is usually very difficult particularly during ebb tide hours due to the shallow water depths that characterize the channel pathways, thus requiring periodic maintenance dredging to safeguard the required minimum navigational depths. Owing to the socio-economic importance of the creek, there is a need to maintain its navigability at all times in order to keep pace with the volume of traffic plying the route. Results from the analyses of preliminary and post-dredged bathymetric surveys carried out over a nine-year period between 2009 and 2017 showed that the channel, which was initially dredged to a threshold depth of 10.0 meters in 2009, had infilled to a new depth of 6.9 meters by the year 2017. Further analysis from the study also showed that approximately 91,000 m³ of sediment volume had deposite

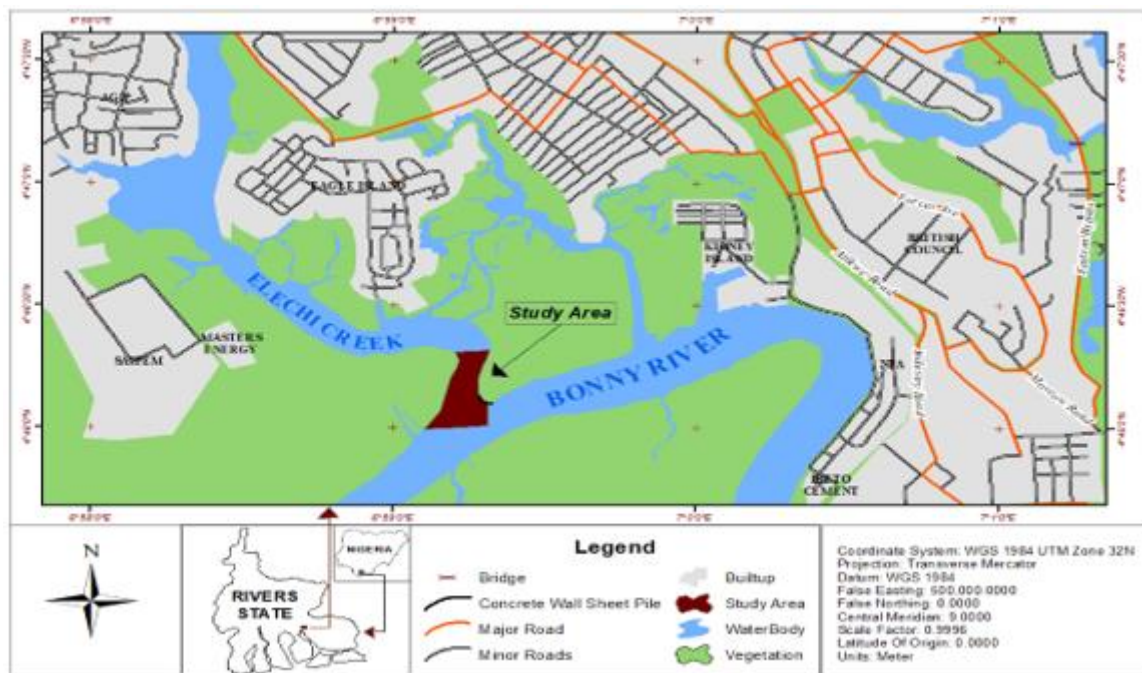
Fig. 1: Digitized map of the study area (Google Earth Imagery, 2017)

The study area was Elechi creek as shown in Fig. 1. It is located on the plain of Niger Delta basin in Port Harcourt City, Rivers State of Nigeria. The creek is one of the many tributaries of the Upper Bonny River estuary and it also has many other adjoining mangrove creeks situated near Eagle Island by the north eastern end of Rivers State University, Port Harcourt. The stretch of the creek is long and wide with meanders. The length is roughly 3.0 km with an average width of about 150 meters.

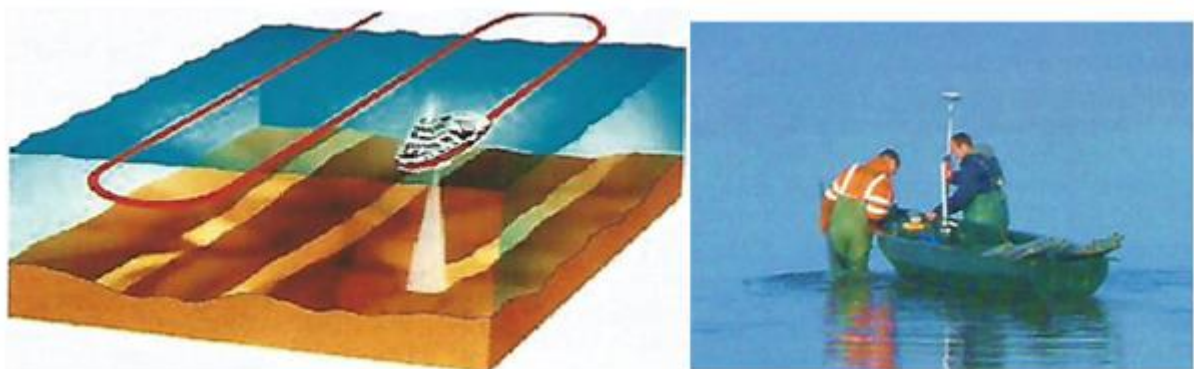
Fig. 3: Depth measurement with SB echo sounder and Position fixing with RTK GPS (Skilltrade, 2010)

along each sounding line. All measurements for depths, position fixes and tides were logged simultaneously in real time at every ship pass. Measured depths were later corrected for tides during data processing. Fig. 3 explains the working principles of a single beam echo sounder and Real Time Kinematics differential GPS respectively.

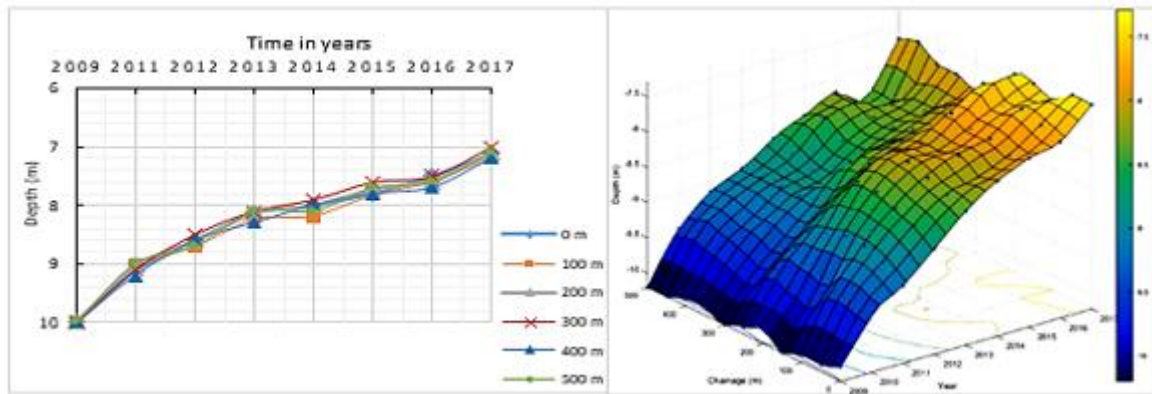
Fig. 10: Graphs of depths variation with time in 2D and 3D plots at monitoring points

channel as at 2009 and 2017 were shown in Fig. 8. Volumetric analyses showing the quantities of sediment infilled into the channel due to deposition over the study periods was presented in Table 2 and Fig. 9, while graphical plots of depths variation with time were presented in Fig. 10.
